PROJECT CHECO SOUTHEAST ASIA REPORT

LOCAL BASE DEFENSE IN RVN

JANUARY 1969 - JUNE 1971

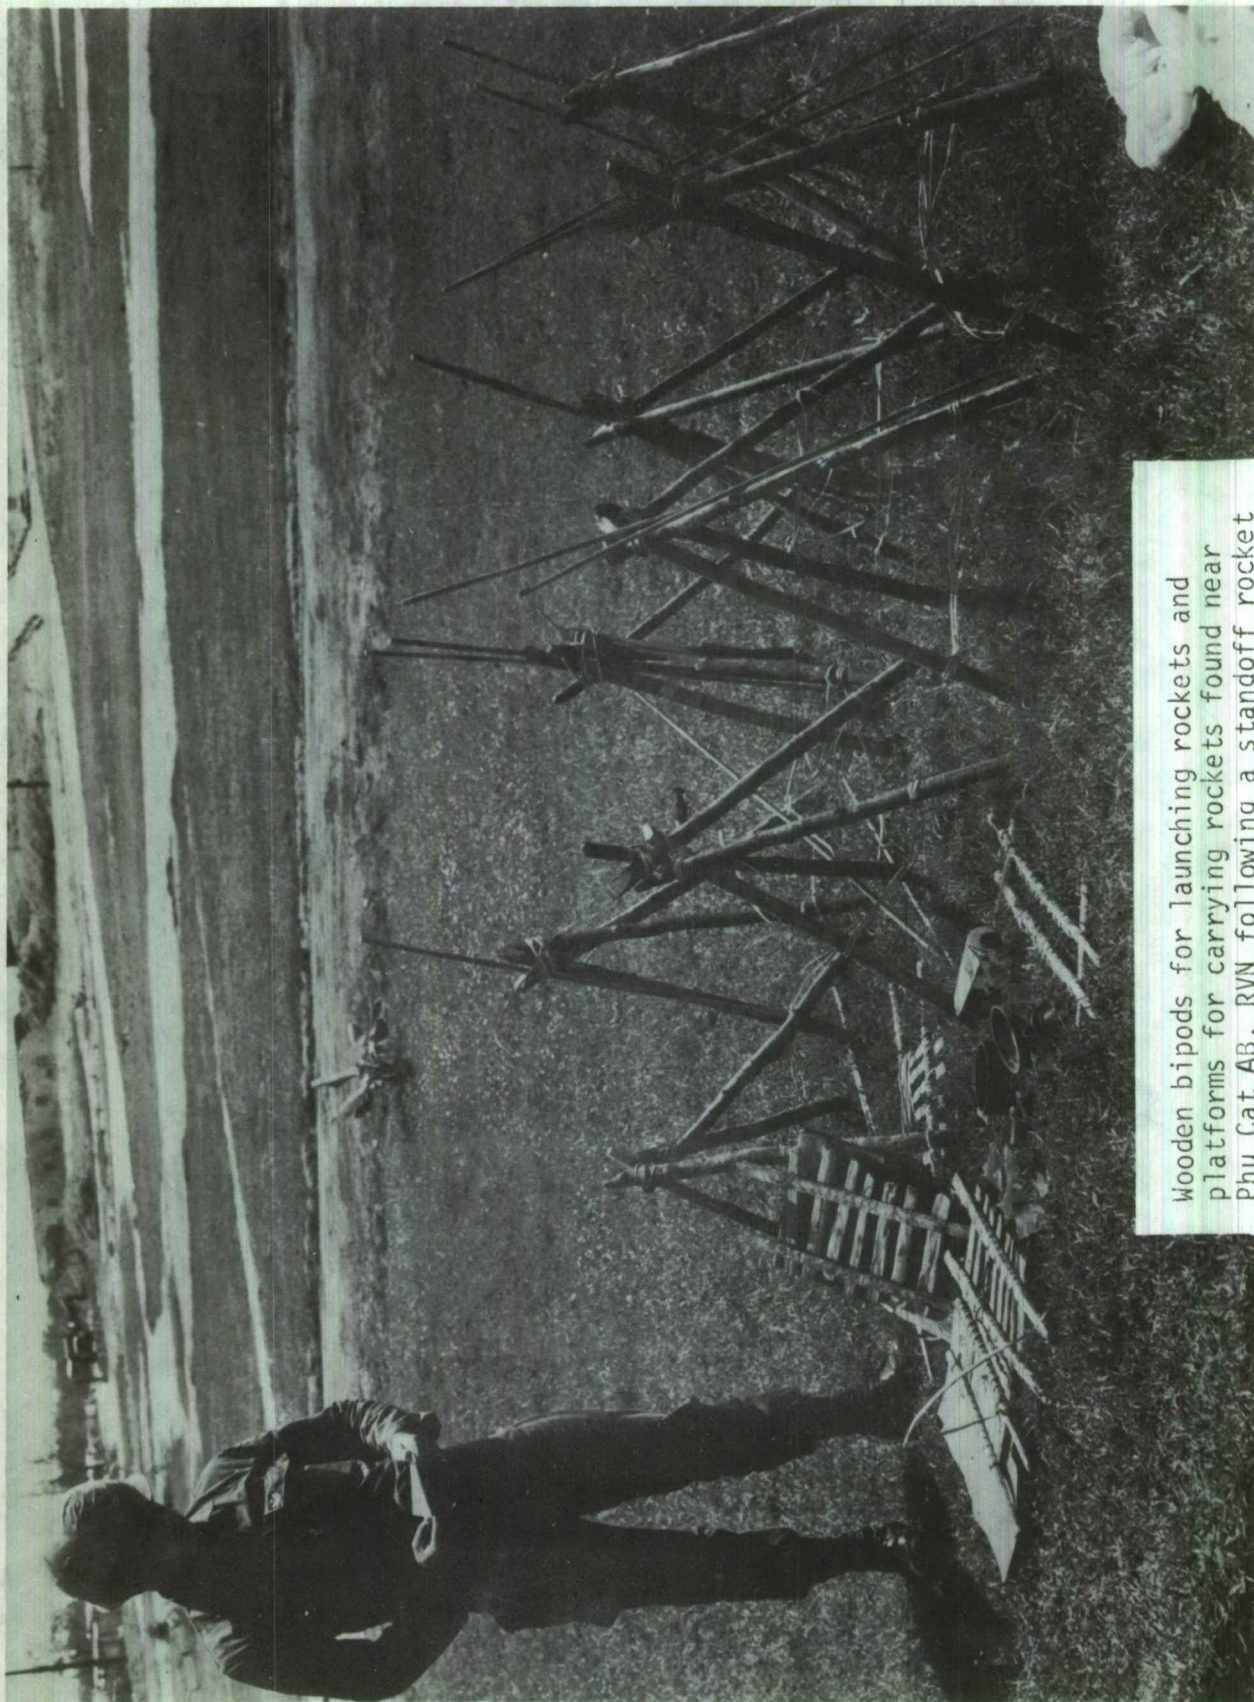
FIGURE 1

Wooden bipods for launching rockets and platforms for carrying rockets found near Phu Cat AB, RVN following a standoff rocket attack on 2 February 1970.

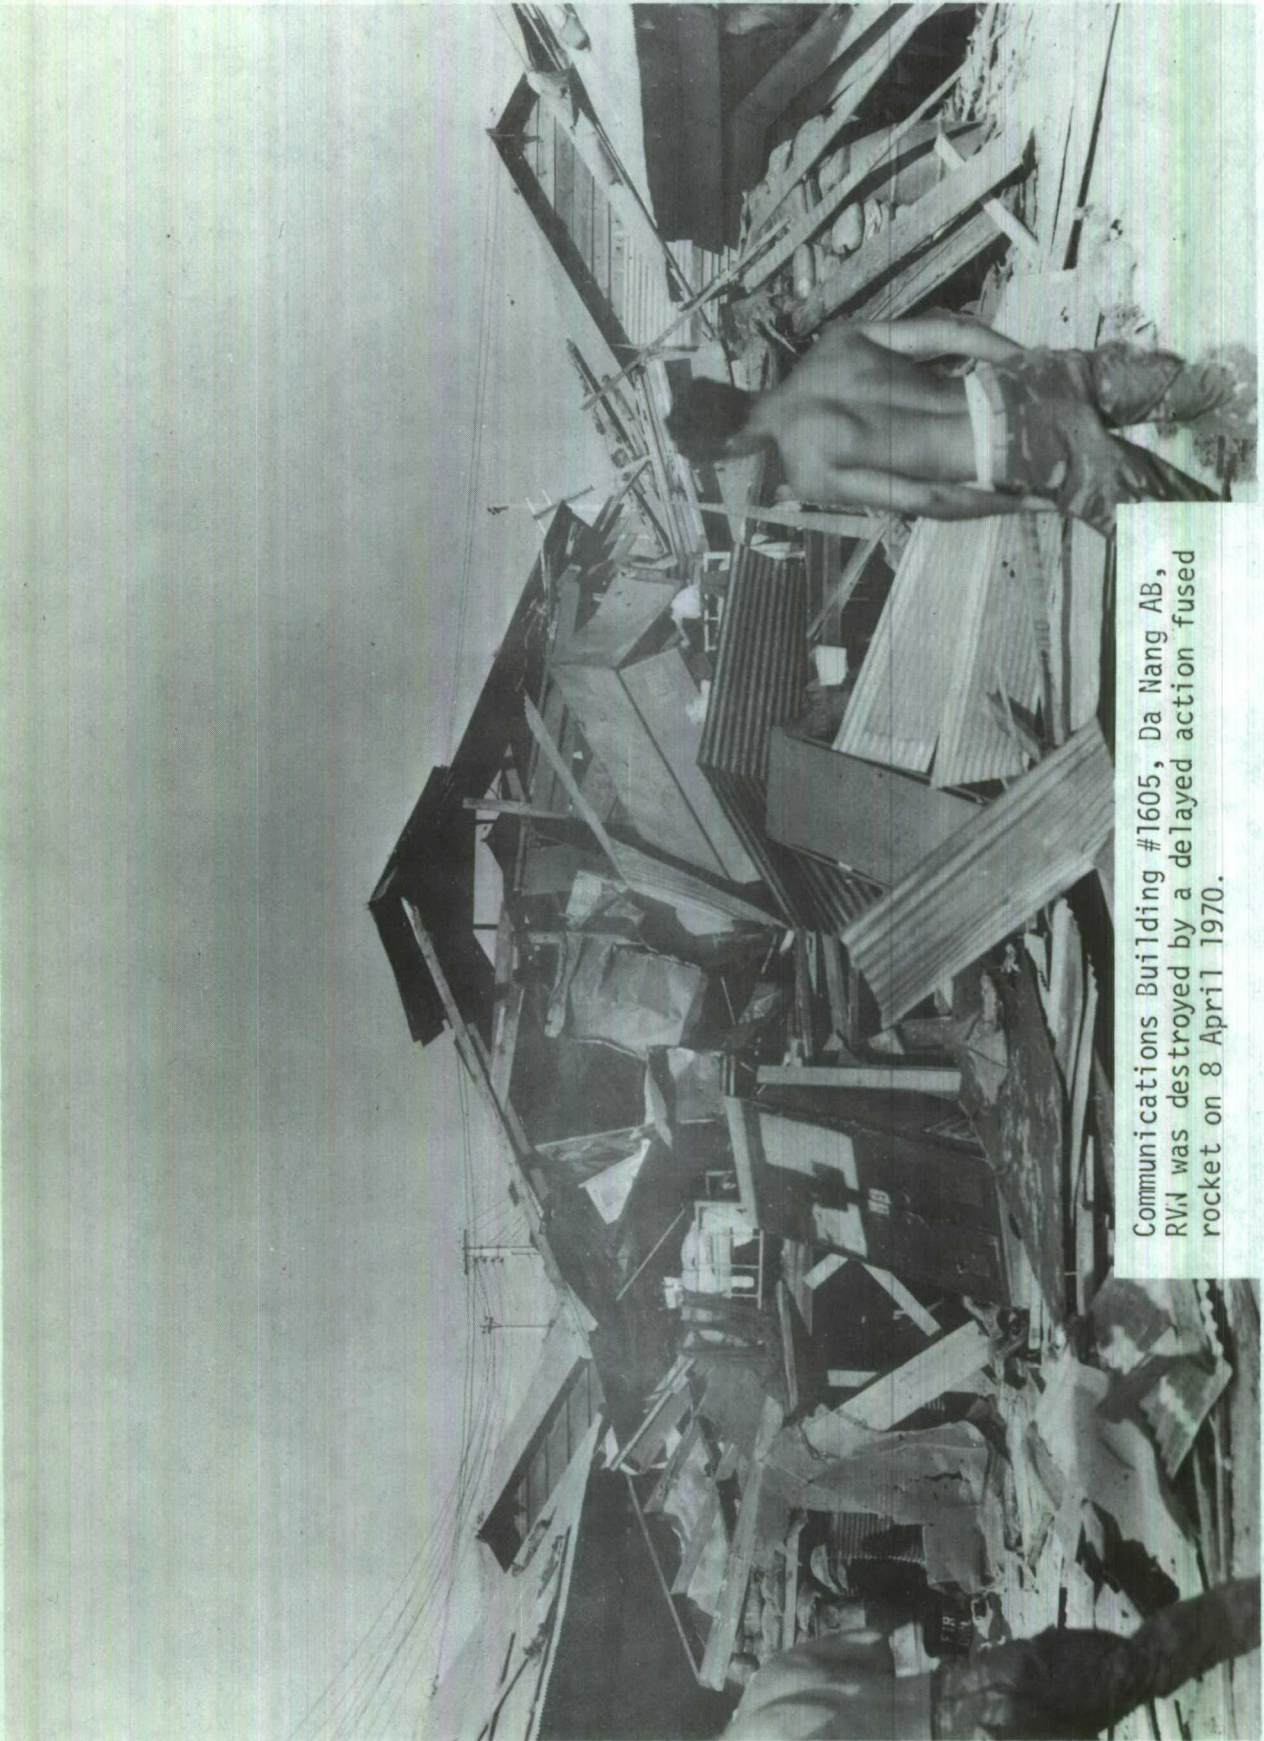
FIGURE 2

Communications Building #1605, Da Nang AB, RVN was destroyed by a delayed action fused rocket on 8 April 1970.

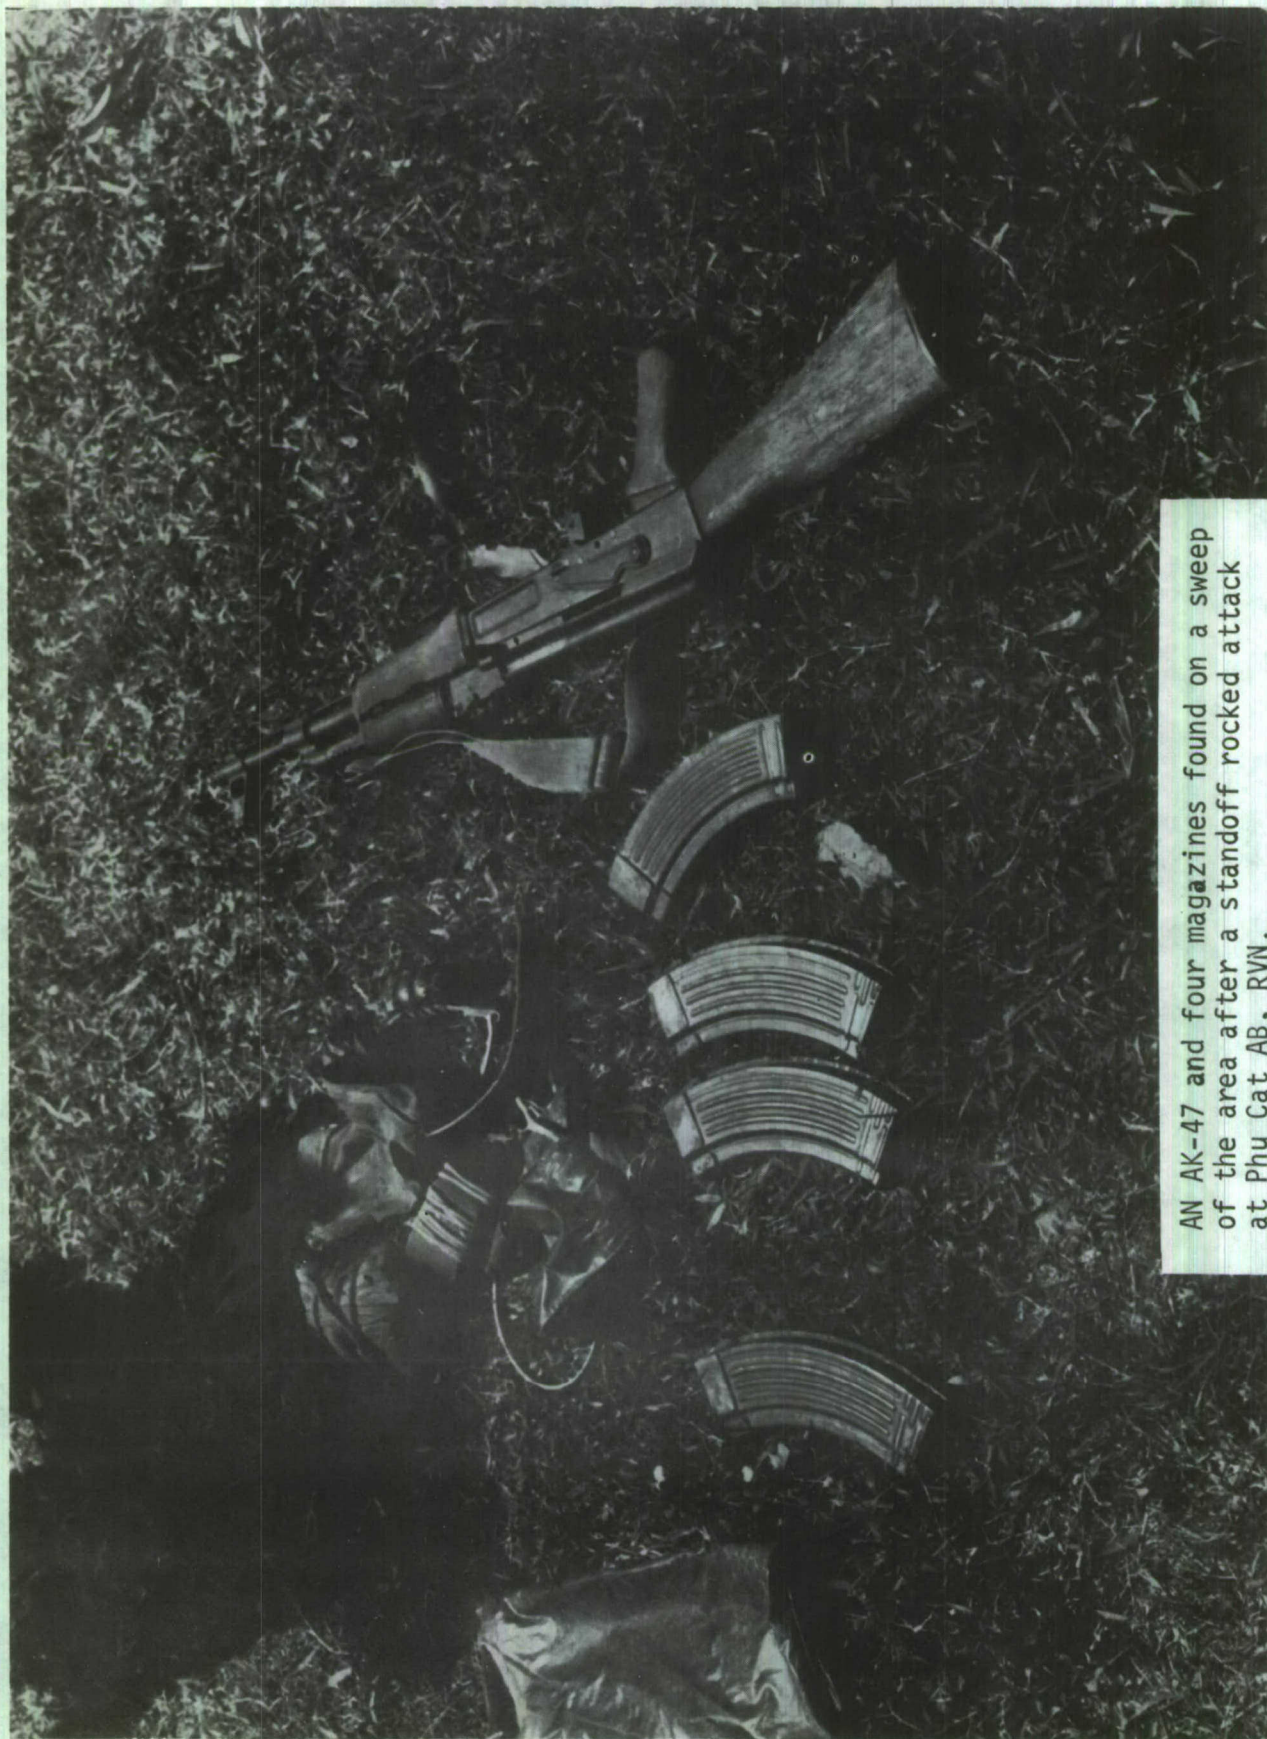
FIGURE 3

AN AK-47 and four magazines found on a sweep of the area after a standoff rocked attack at Phu Cat AB, RVN.

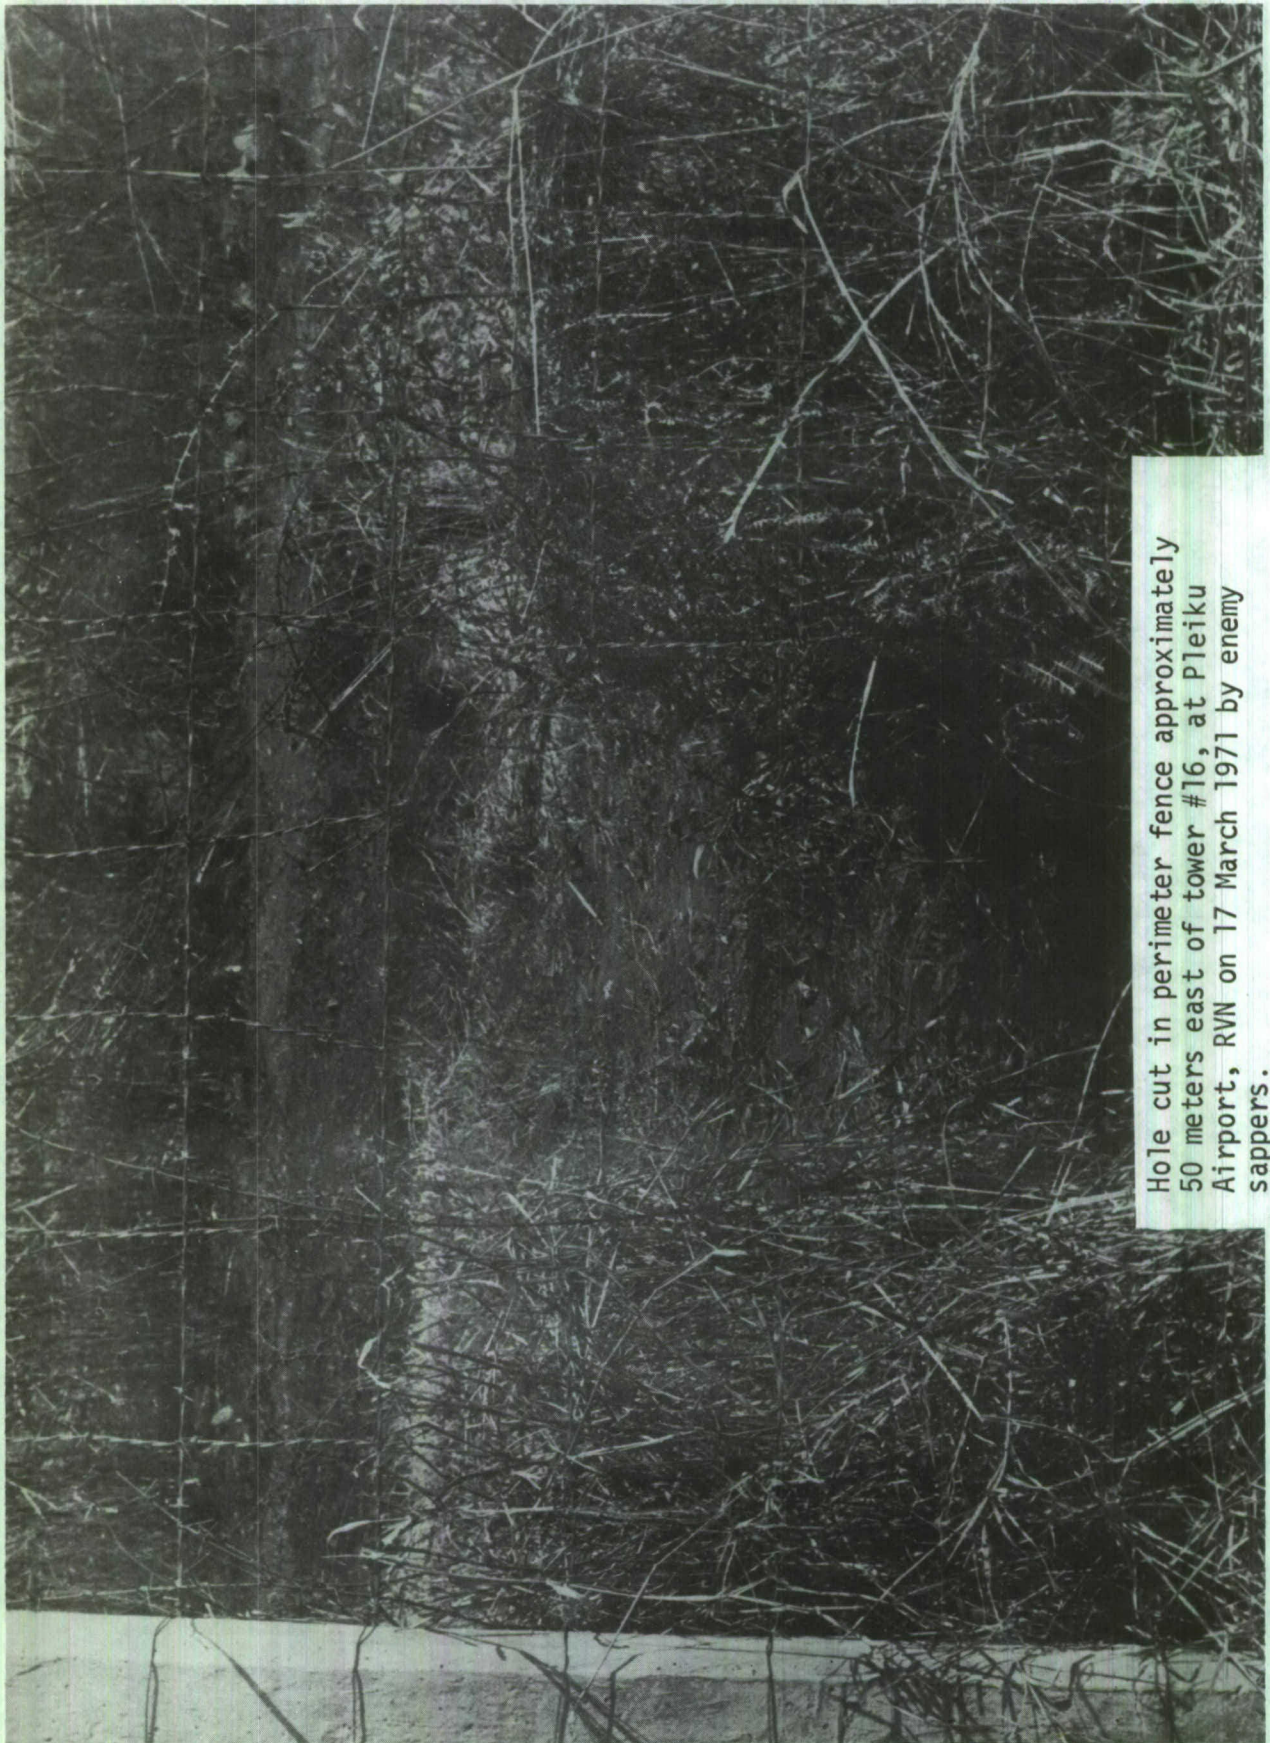
FIGURE 4

Hole cut in perimeter fence approximately 50 meters east of tower #16, at Pleiku Airport, RVN on 17 March 1971 by enemy sappers.

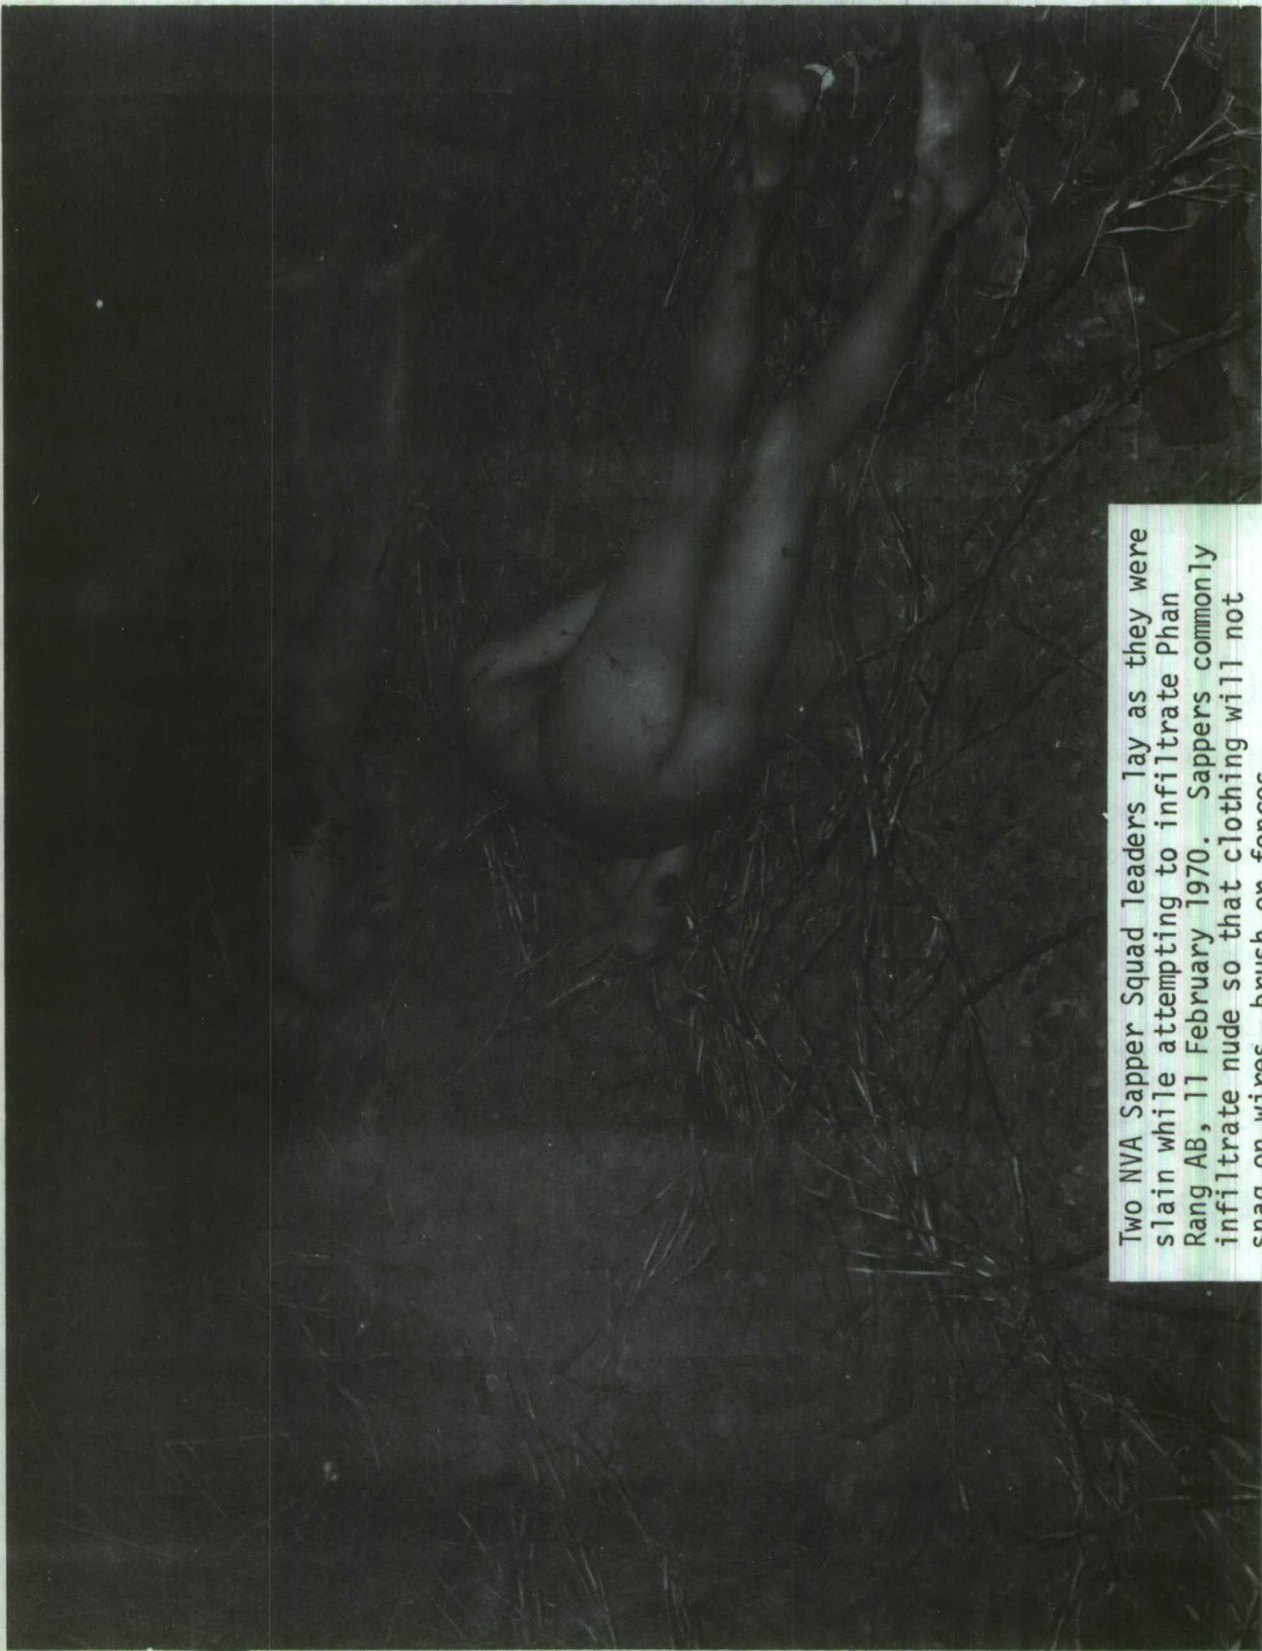
FIGURE 5

Two NVA Sapper Squad Leaders lay as they were slain while attempting to infiltrate Phan Rang AB, 11 February 1970. Sappers commonly infiltrate nude so that clothing will not snag on wires, brush or fences.

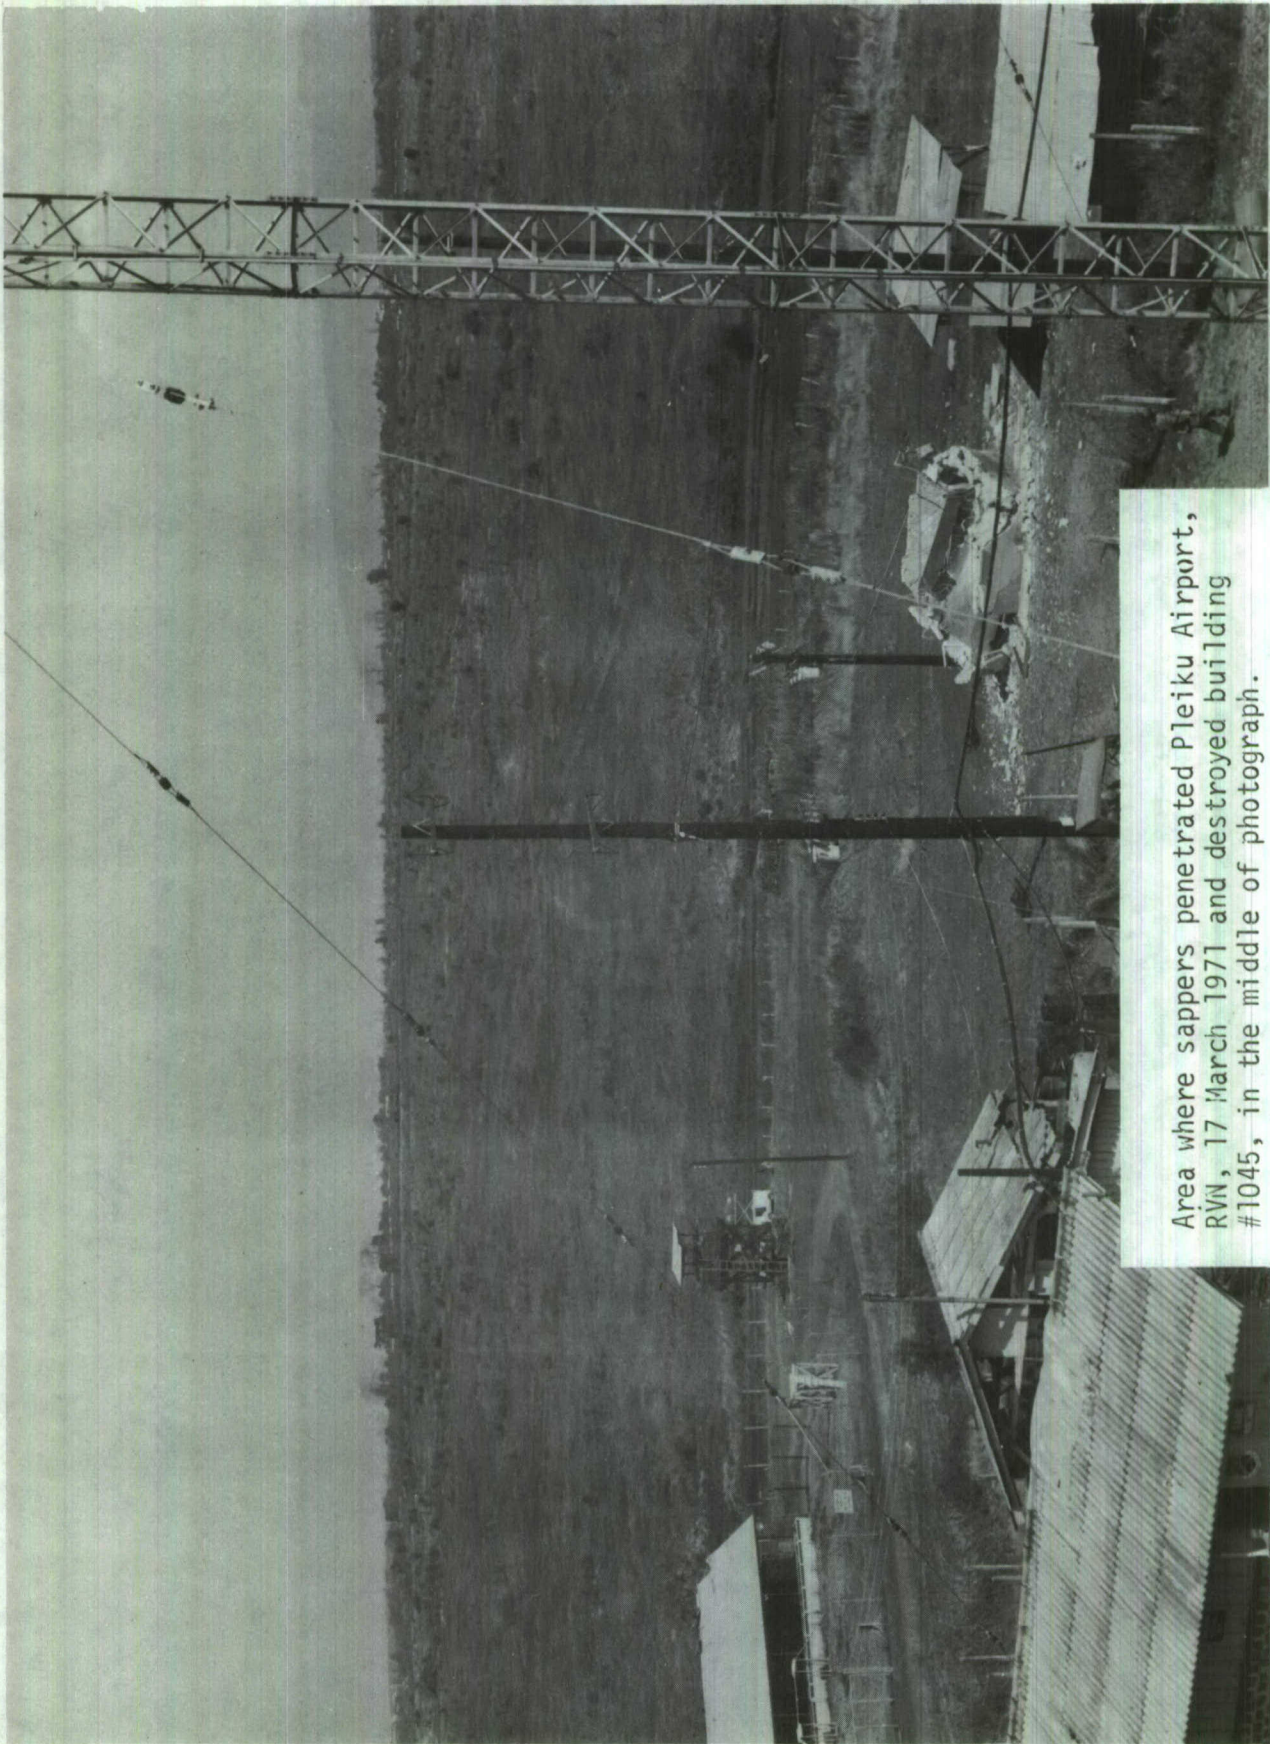
Area where sappers penetrated Pleiku Airport, RVN, 17 March 1971 and destroyed building #1045, in the middle of photograph.
